TWO LICK CREEK DAM

NDI No. Pa. - 285

**PHASE I INSPECTION REPORT  
NATIONAL DAM INSPECTION PROGRAM.**

GAI CONSULTANTS, INC.  
570 BEATTY ROAD  
MONROEVILLE, PENNSYLVANIA 15146

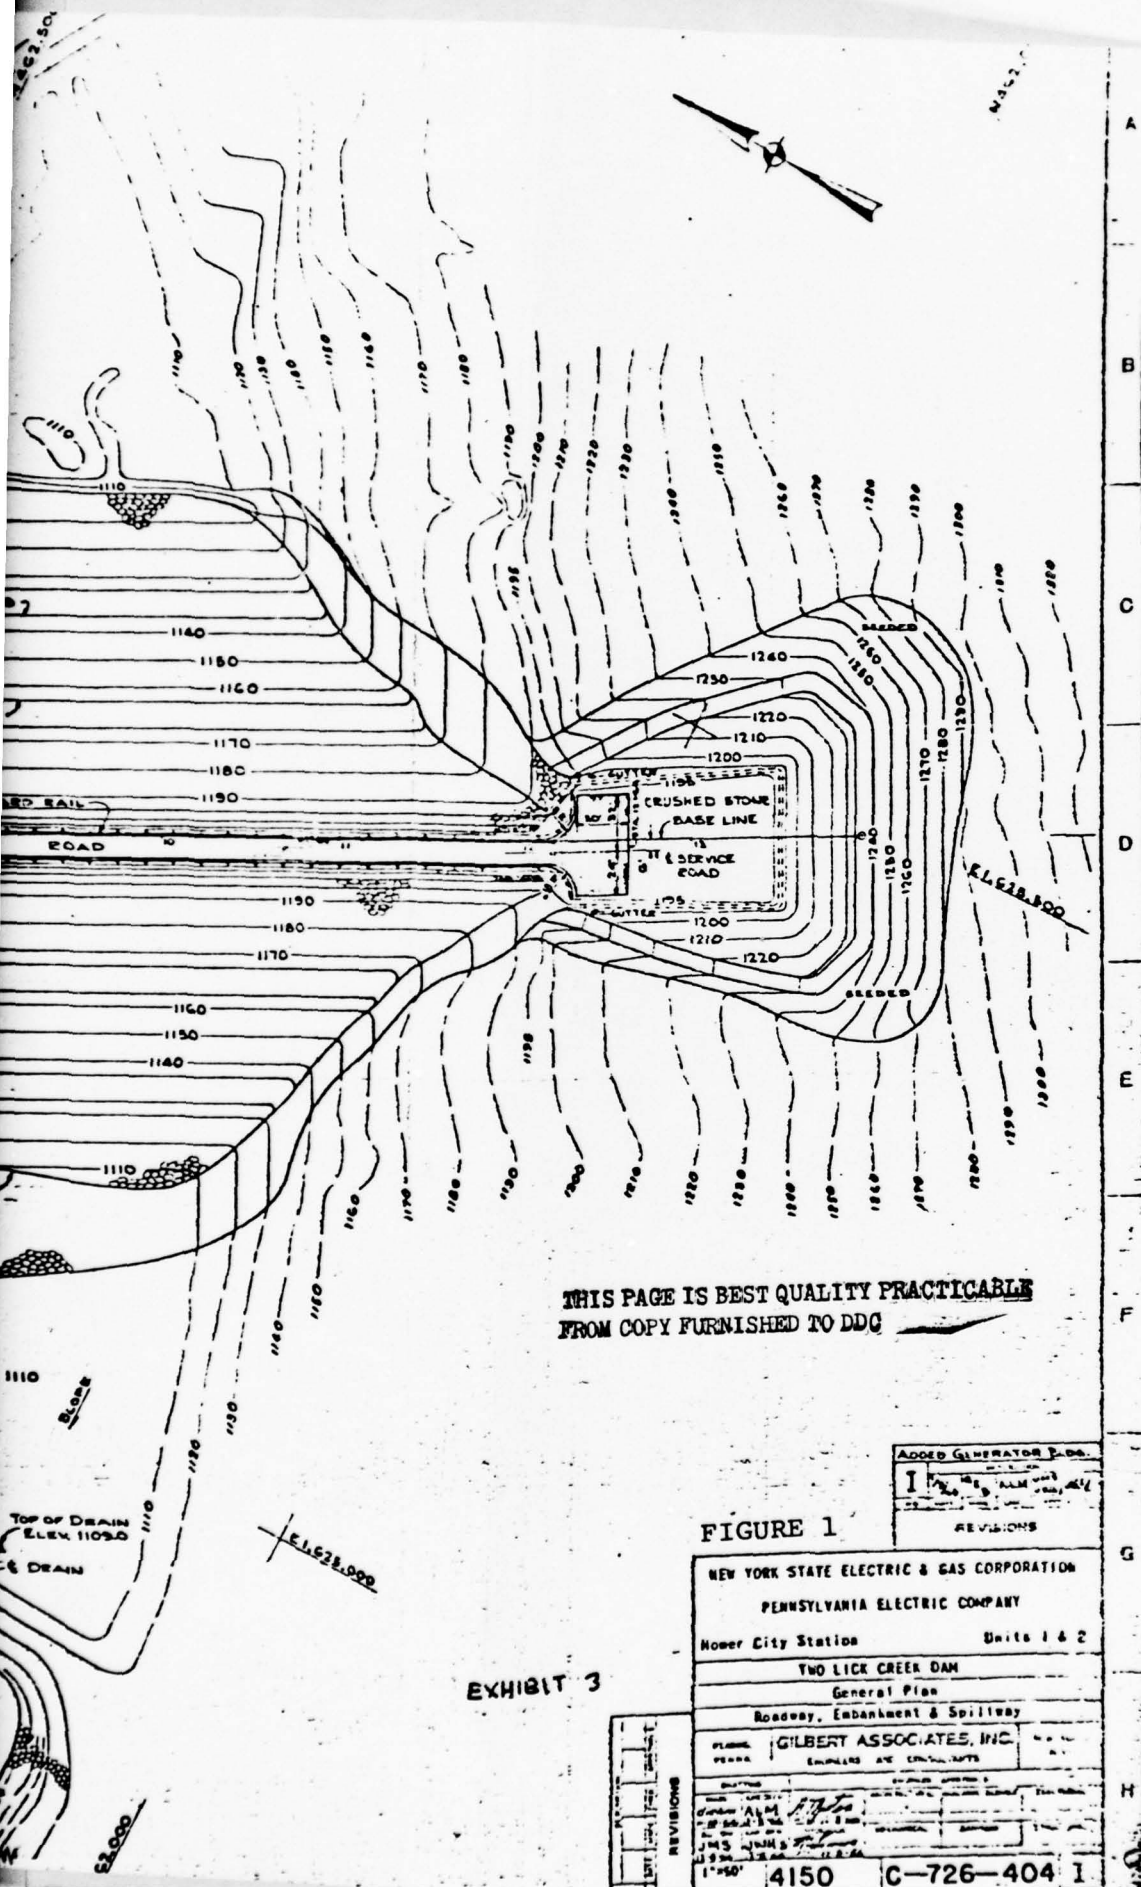
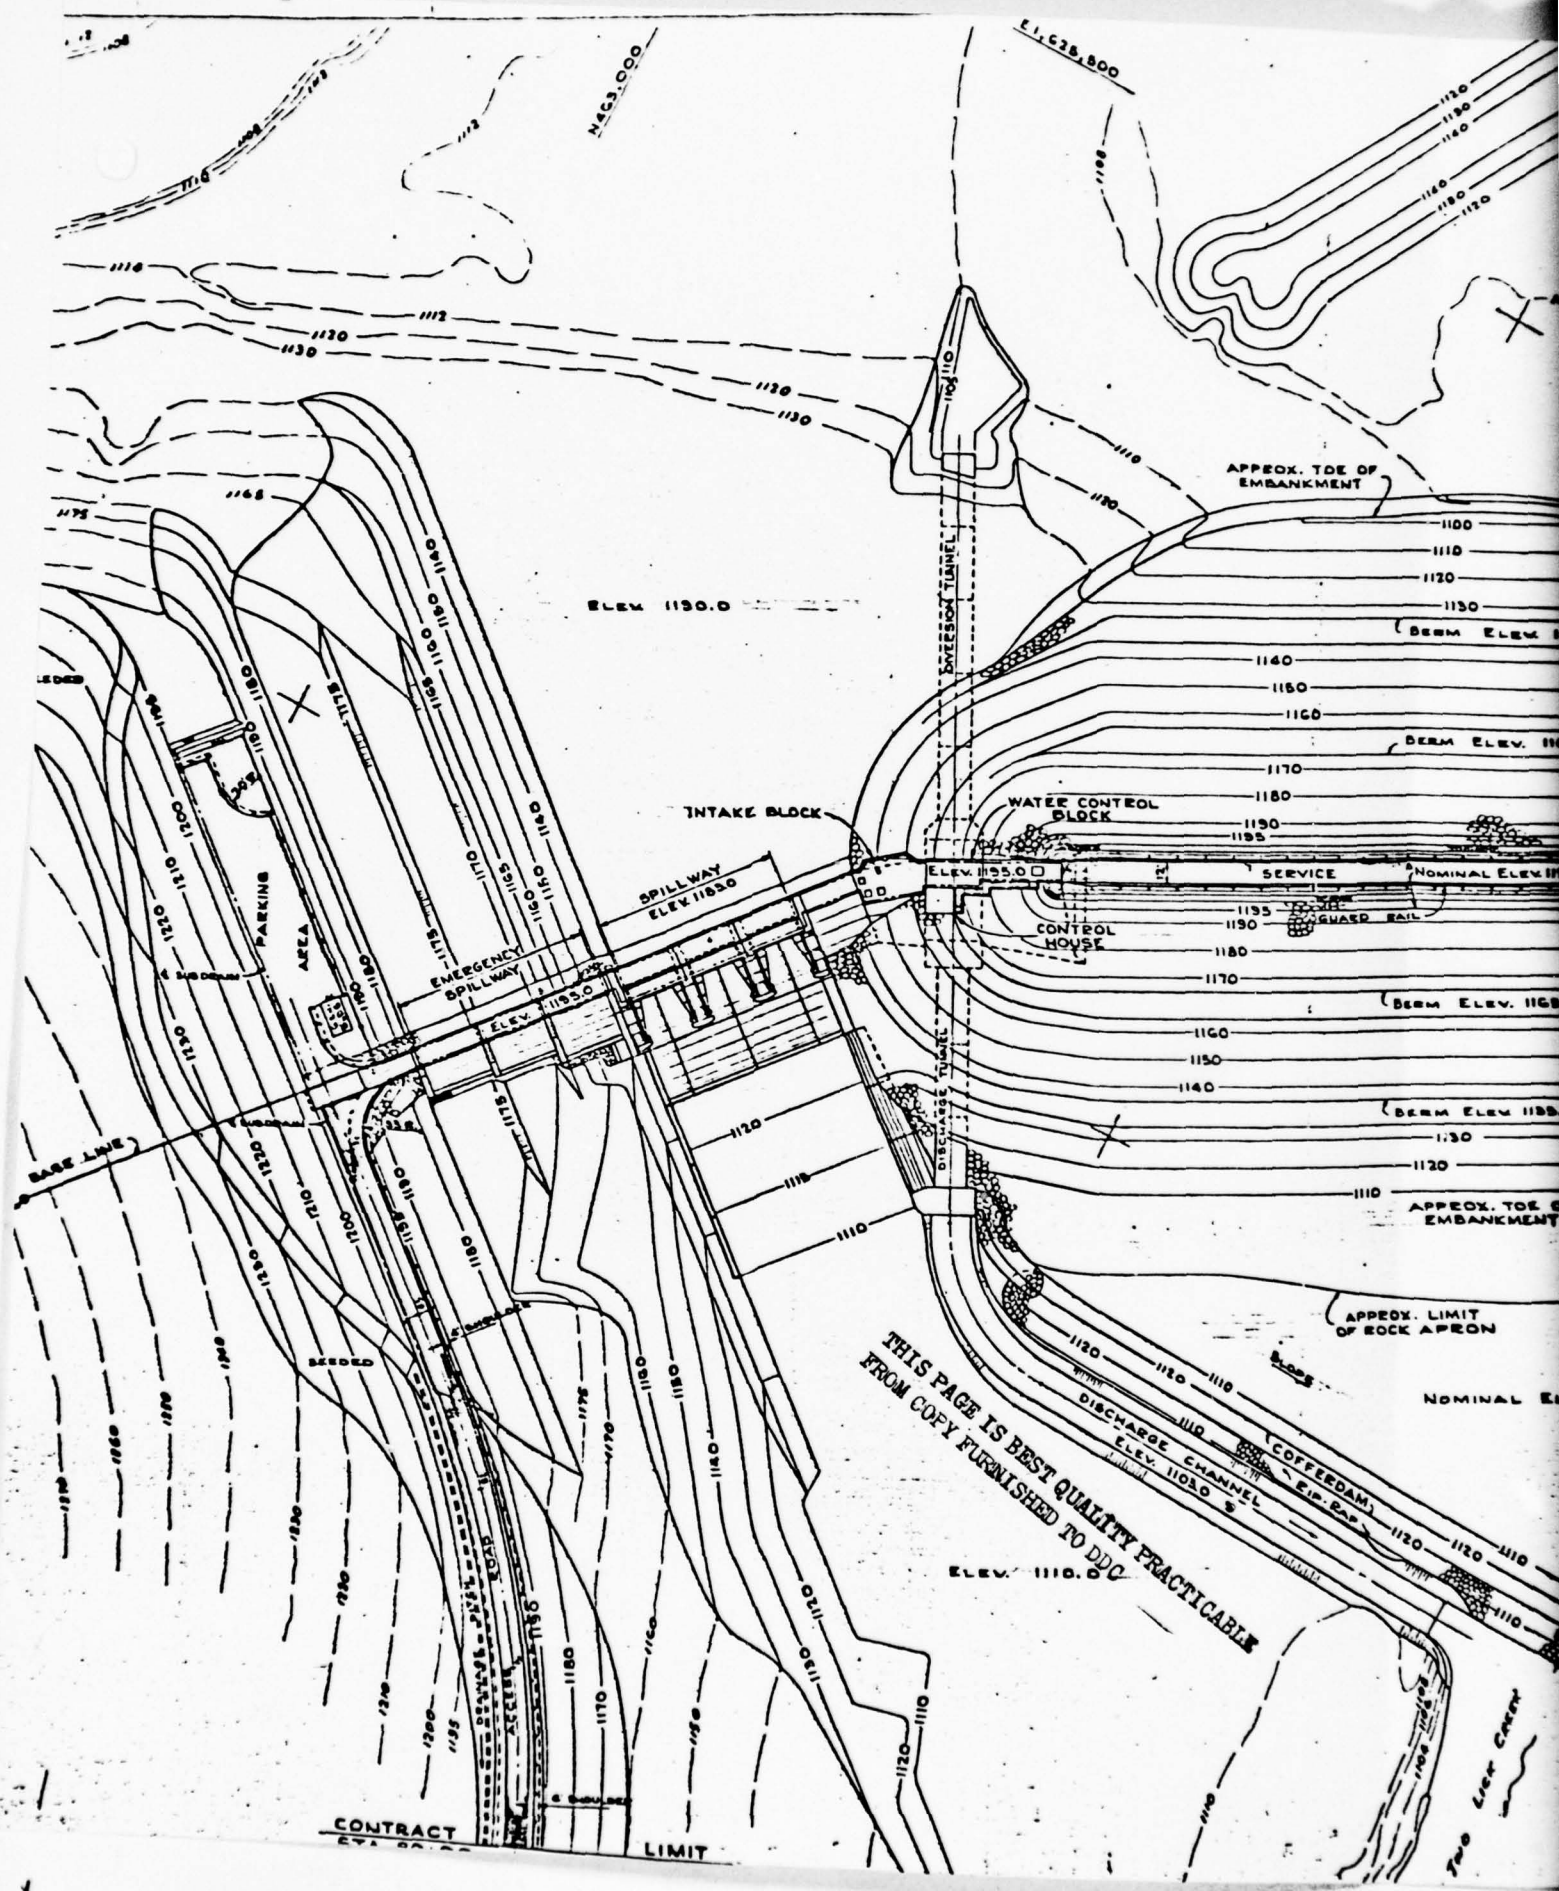
FIGURE 1

a. Dam and Appurtenances. Two Lick Creek Dam is a combination concrete gravity and earth- rockfill embankment. It is approximately 1,200 feet long with a maximum height of 115 feet. The right side of the structure is a concrete gravity dam with six concrete ogee-shaped overflow spillway bays. The three bays located nearest to the right abutment (defined as Bays 1, 2, and 3 of this report) are uncontrolled and function as the emergency spillway. The three bays located to the left of the emergency spillway (defined as Bays 4, 5, and 6 of this report) are equipped with mechanically operated radial gates. These bays function as the primary spillway with crests 33.5 feet lower than the crests of the emergency spillway. In addition, the facility is equipped with a discharge tunnel (concrete box culvert type) located to the right of the junction between the concrete and earth- rockfill sections of the structure. The left side of the structure is an earth- rockfill embankment which wraps around the left extremity of the concrete dam (see Figure 1, Appendix F).

Downstream Channel - The primary spillway discharges into a spillway bucket before entering the natural downstream channel. A dike has been constructed to the left of the natural channel to divert flow away from the embankment toe (see Figure 1, Appendix F).

Upstream Channel - Available drawings indicate the emergency spillway bays have individual approach channels cut into rock on the right abutment (see Figure 1, Appendix F).

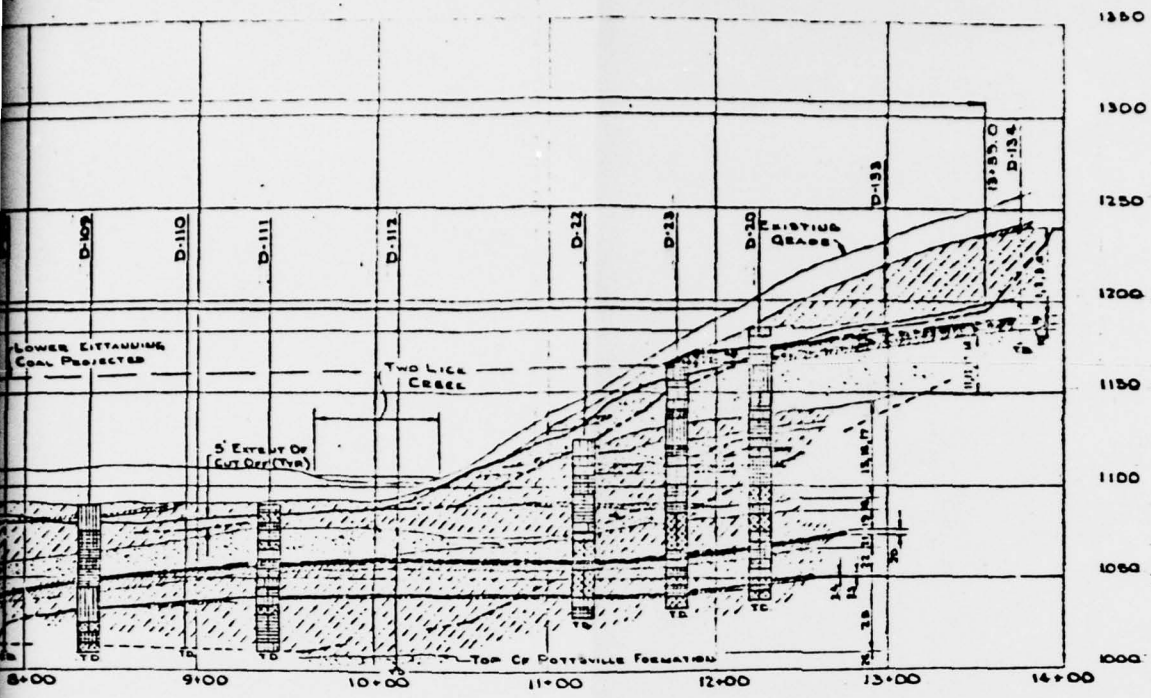
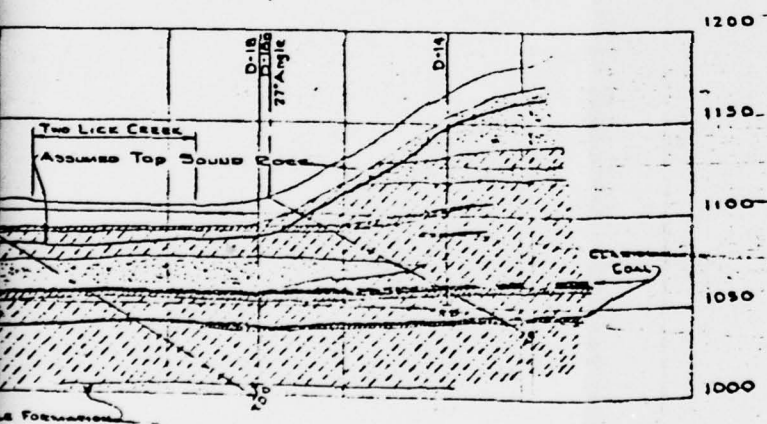
FIGURE 4

The stability of various sections of the concrete structure were analyzed separately. The results are shown on Figure 4, Appendix F.

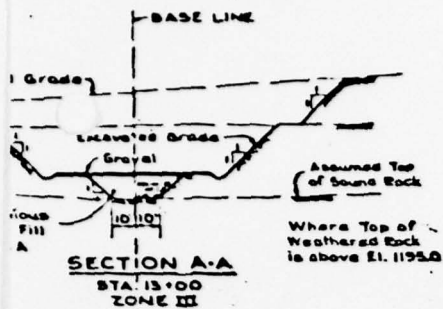
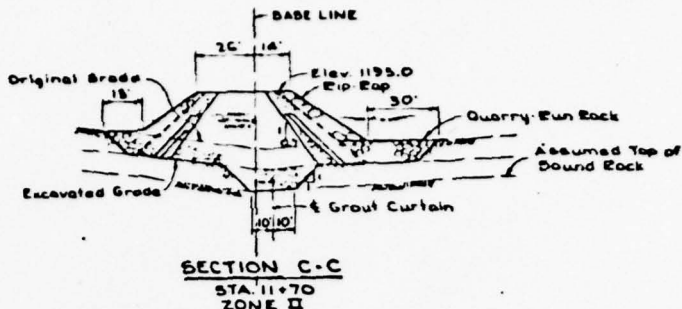
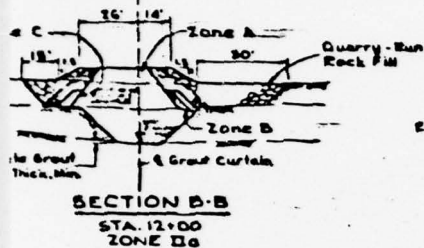
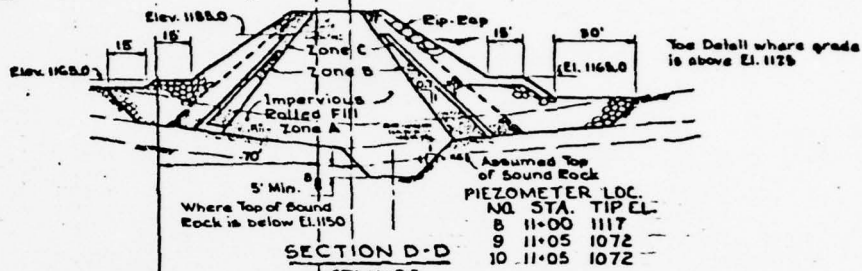
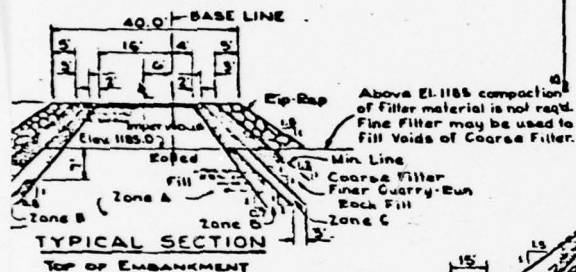
FIGURE 5

Grout Curtain - Contract drawings indicate a grout curtain in the center of the cutoff trench under the embankment section of the dam and upstream from the concrete gravity and spillway sections of the dam. The design report indicates the grout curtain was extended to a depth of approximately 80 feet across the valley, and into the abutment to a distance and depth sufficient to minimize appreciable water movement (see Figure 5, Appendix F).

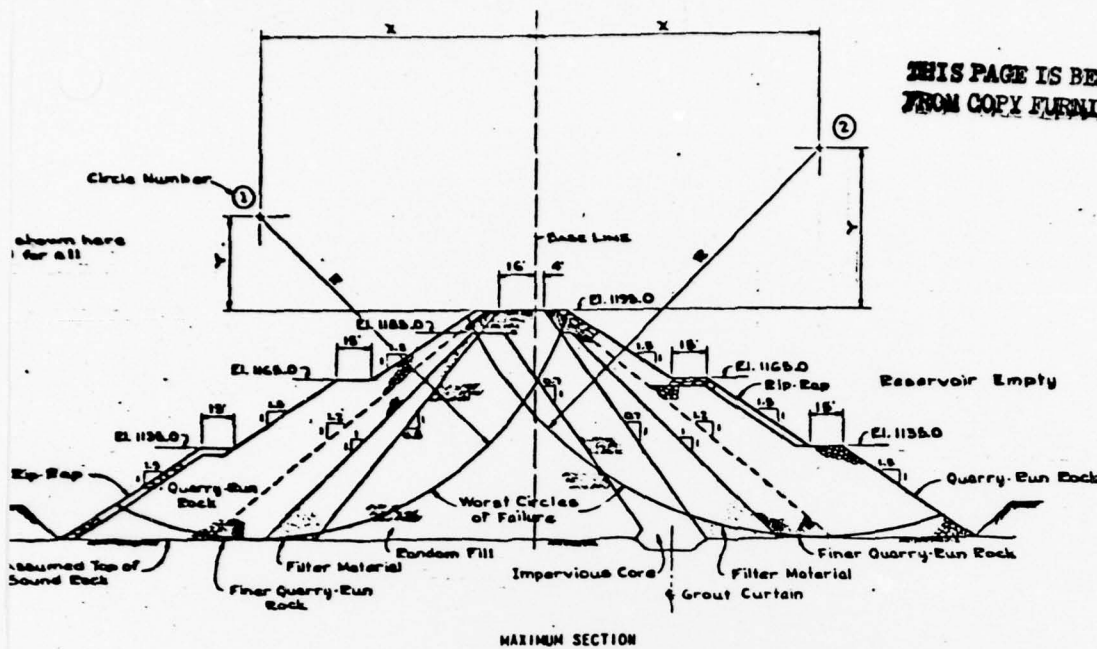
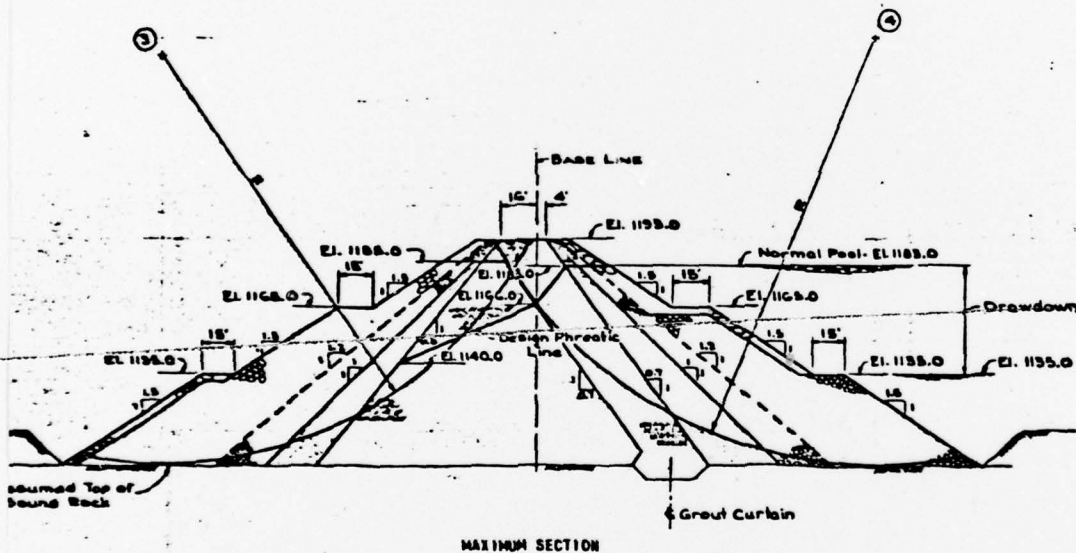
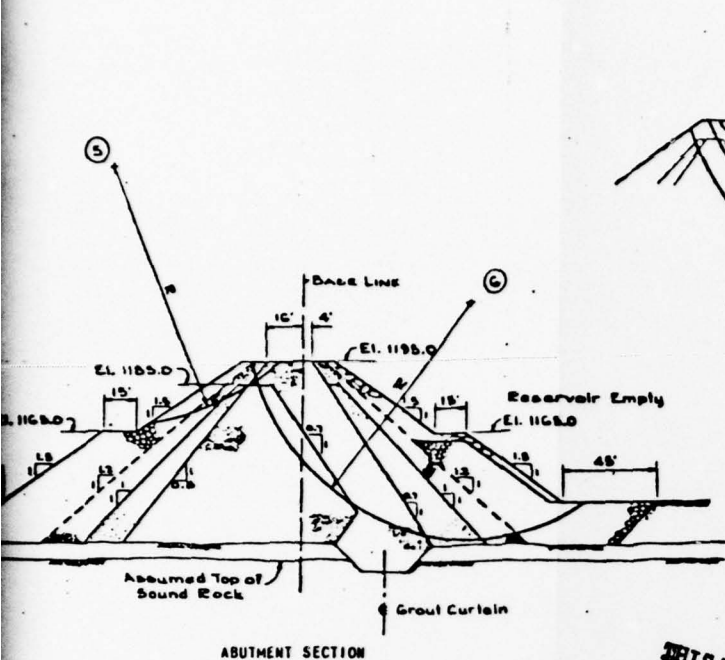
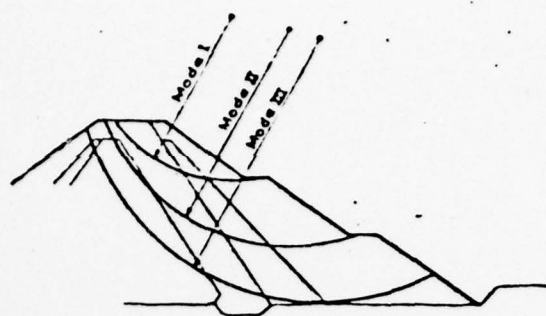
Slope stability was performed with an IBM 1620 computer program, utilizing a modified Swedish circle method. Full consideration for saturated and submerged conditions are written into the program. The results obtained by this method are conservative. Nominal factors of safety were the desired results, since conservative soil strengths and method of analysis were used. For final analysis, 24 complete cases were run, many with varying strengths of earth-fill. The results are shown on Figure 7, Appendix F, and are representative of the minimum factors of safety obtained.

For each section of discontinuous slope there is a separate mode of failure which will give a "minimum" factor of safety. Materials at higher elevations in the fill have higher design strengths due to smaller pore pressures. Table I gives the phi angle values by case & mode. The lower modes are shown on the maximum section & the higher modes are shown on the abutment section.
